# ADRE® for Windows saves a generator

*Proximity probes installed for more accurate data*

**by Mogens Greve**  
*Engineer B.S.C.M.E.  
Asnæs Power Station  
Denmark*

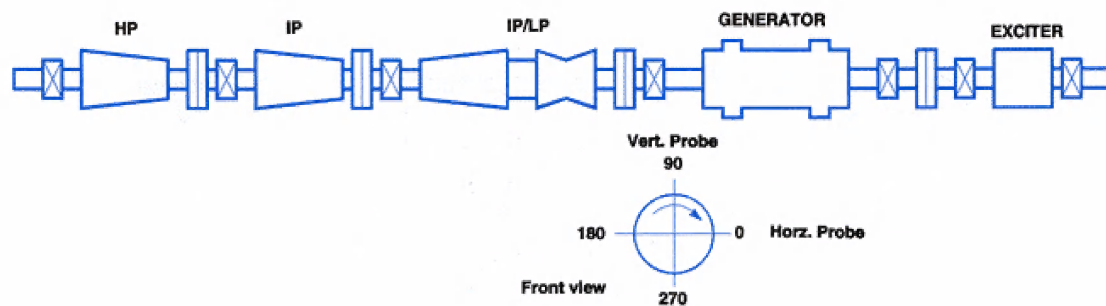
Figure 1:  
Asnæs Turbine Unit 1 machine train diagram.

Asnæs' Unit No. 1 consists of a high pressure (HP) turbine, intermediate turbine (IP), combined intermediate and low pressure turbine (IP/LP), and a generator (Figure 1). Since its commissioning in 1959, Unit 1 has operated approximately 200,000 hours. In 1985, it was rebuilt and upgraded to 150 MW. The HP and IP turbines were replaced, the combined IP/LP turbine had new turbine blades installed, and the two-pole generator windings and retaining rings were also replaced.

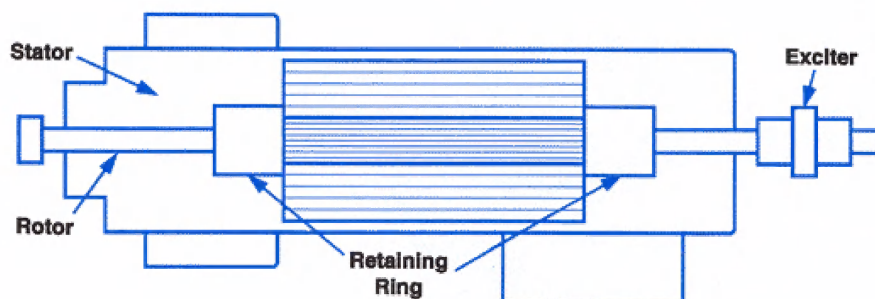
Figure 4:  
Cutaway drawing of generator showing windings and retaining rings.

body. A single bar on top of the upper copper bar is called the "damping winding bar." Retaining rings hold the generator windings in place at each end of each pole. Electrical insulation between the retaining rings and generator windings prevents the windings from shorting on the retaining rings (Figure 4). We suspected either that grooves in the damping winding bar were pressing against the retaining rings or that the indirectly-cooled copper bar windings were pressing against the backplate of the retaining rings.
